Repair & Re-Lining of severely corroded Chimney Stack Internals with Duromar SAR & Duromar EXP

Scenario Description

Aggressive corrosion damages & metal loss were noticed on the flue can internals of a Chimney Stack at a 1300 MW Coal Fired Power Plant.

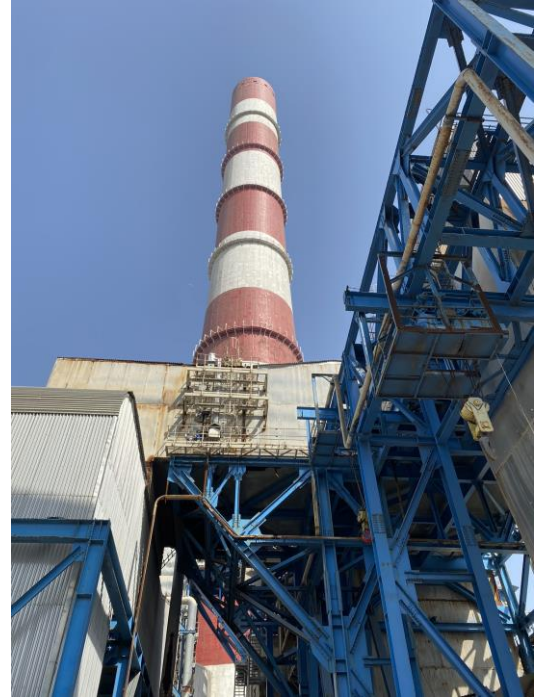
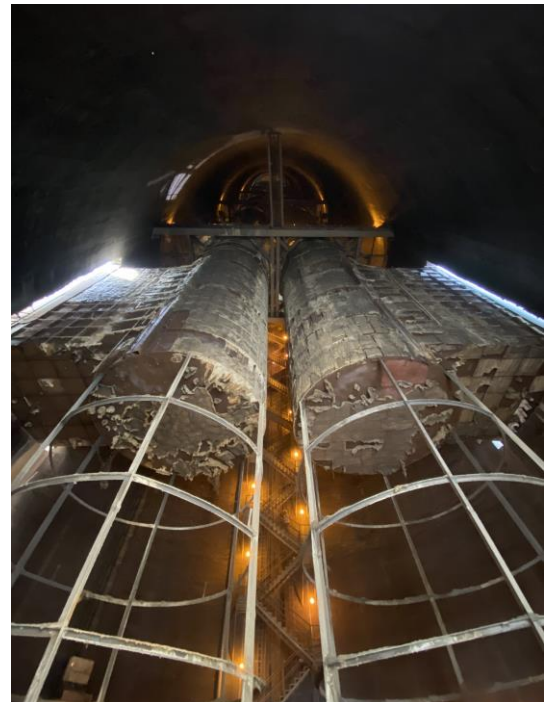
The carbon steel chimney had been in operation for over 5 years and the internal surfaces were cladded with titanium sheets.

Overtime however, dew-point corrosion had caused severe damages to the titanium cladding and as a result had significantly weakened the chimney structure.

275-meter-tall & 7-meter diameter Carbon Steel Chimney stack, internally cladded with titanium Gr2 liners.

The Chimney Stack was connected to a Wet Flue Gas Desulfurization (FGD) system and with wet H₂SO₄ fluid fumes and pH levels as low as 2.

The operating temperatures varied between 60°C to 150°C under continuous operation with flue gas velocity of approximately 24 mtr/sec.

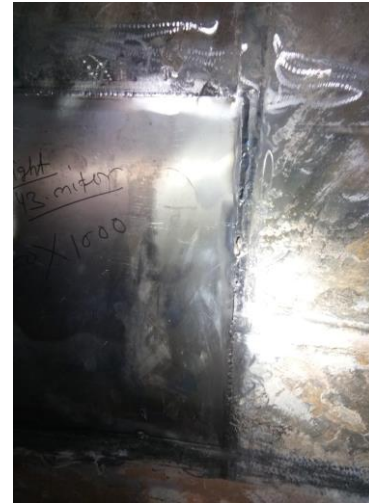
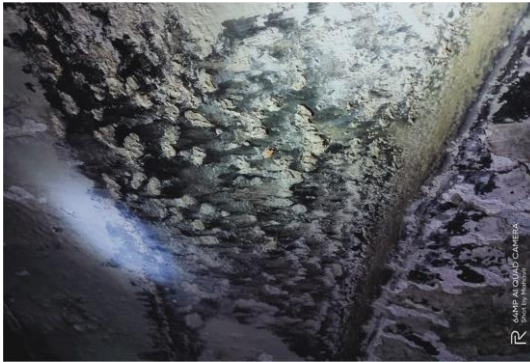
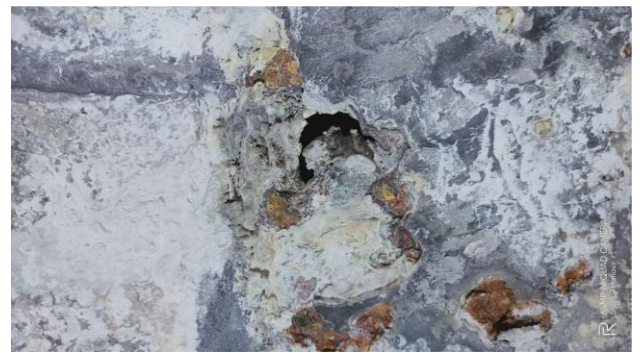
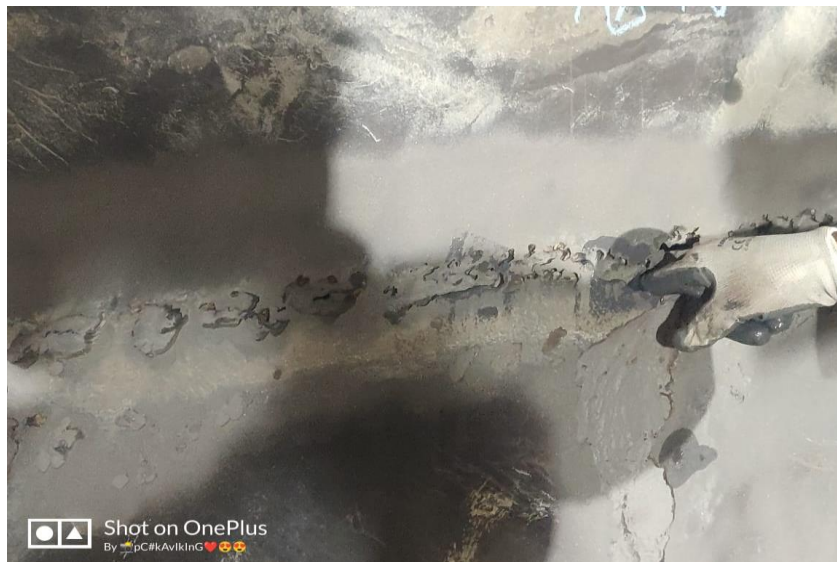
Upon inspection, it was noted that the weld joint areas of the titanium liners had been significantly impacted because of the dew-point corrosion and stood as the primary area of concern with regards to any further aggravation and metal loss.

The weld joint areas were 2.5 inches thick and desperately needed to be repaired to avoid any further surface metal damages.

Severe corrosion damages noticed on weld joint areas of titanium cladded internal surface of chimney stack

Arudra identified the need to protect the weld joint areas with a highly chemical & temperature resistant epoxy novolac that also provided enhanced flexibility under continuous operation.

Duromar EXP, a 100% solid (Zero VOC) epoxy novolac with outstanding chemical & cavitation resistance and excellent fluid flow characteristics was applied along the weld joint areas of the titanium sheets at a thickness of 2.5mm – 3mm.

The weld joint surfaces were abrasive blasted using aluminium oxide grid (as per SA 2.5 standards), to achieve a surface profile of 80 - 120 microns and to ensure highest quality adhesion levels.

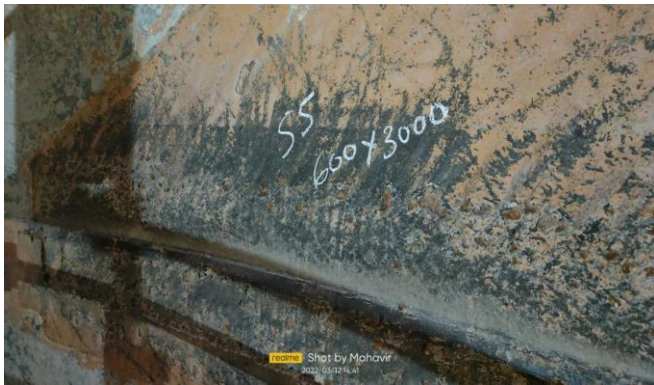
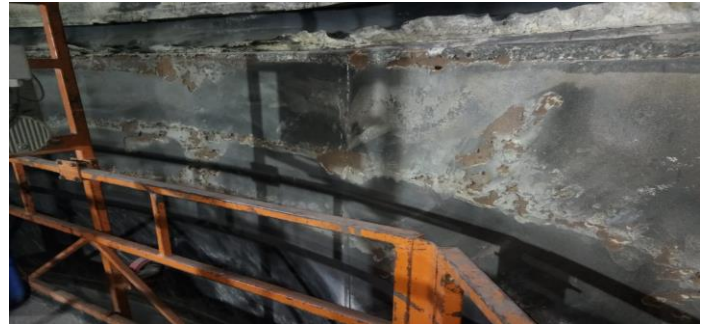
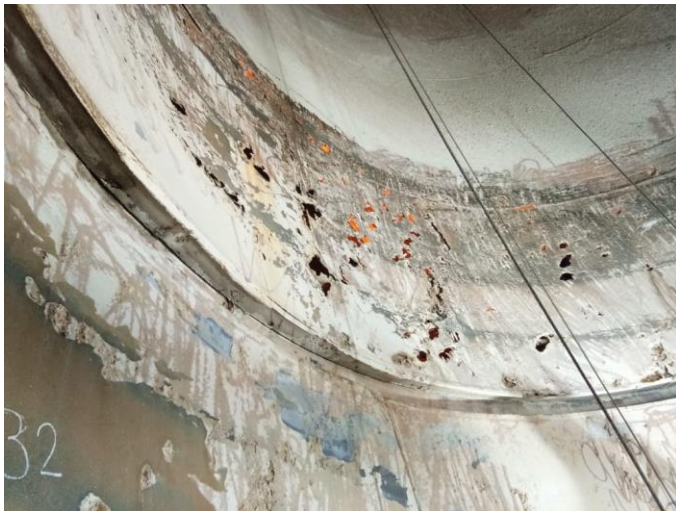
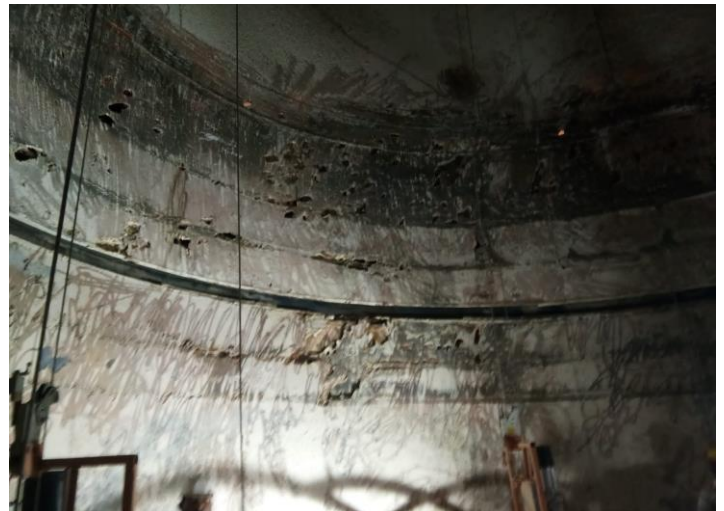
Given the aggressive operating conditions and fluctuating temperatures, it was also noted that the elevated surfaces (above 50 metres) were severely damaged because of Sulphuric Acid corrosion.

Despite the protective barrier being of titanium grade, corrosion damages had aggravated to such an extent that the parent metal of chimney had severely weakened over the course of operation.

Corrosion damages of upto 10mm was noticed across several areas of the chimney internals, exposing the stack to the risk of complete collapse if not rectified.

Severe corrosion damages noticed on titanium clad internal surfaces of chimney stack

Given that pitting's of upto 10mm in depth were noticed across several areas of the stack base surface, Arudra proposed to rebuild the damaged portions with a ceramic putty **Duromar SAR** & topcoat the surfaces with the flexible epoxy novolac **Duromar EXP** at an average thickness of 2mm-2.5mm.

Duromar SAR is a versatile easy-to-use rebuilding putty with excellent abrasion and chemical resistance. This product is heavily filled with aluminium oxide and can be built up to an inch in thickness or more.

Like the weld joint surfaces, the plain surfaces were abrasive blasted (aluminium oxide grid as per SA 2.5 standard) to achieve a minimum blast profile of 80 – 100 microns.

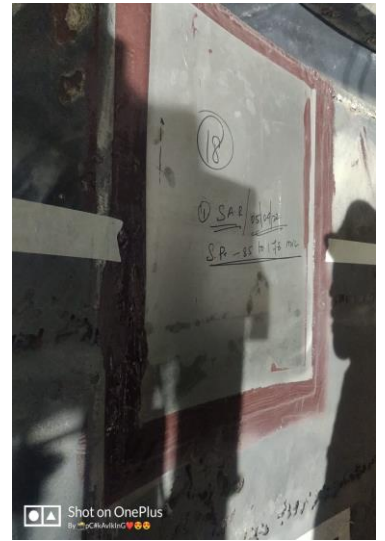
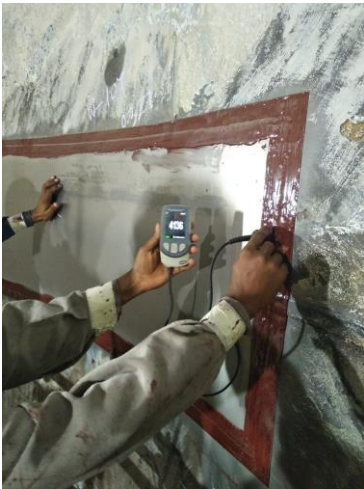
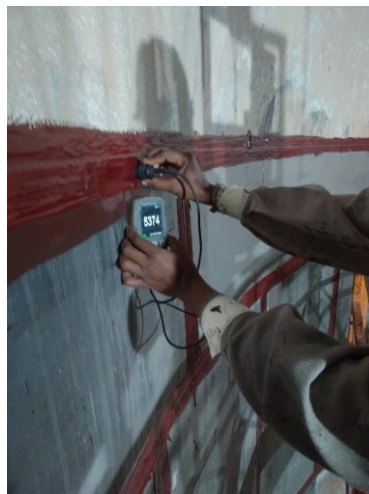
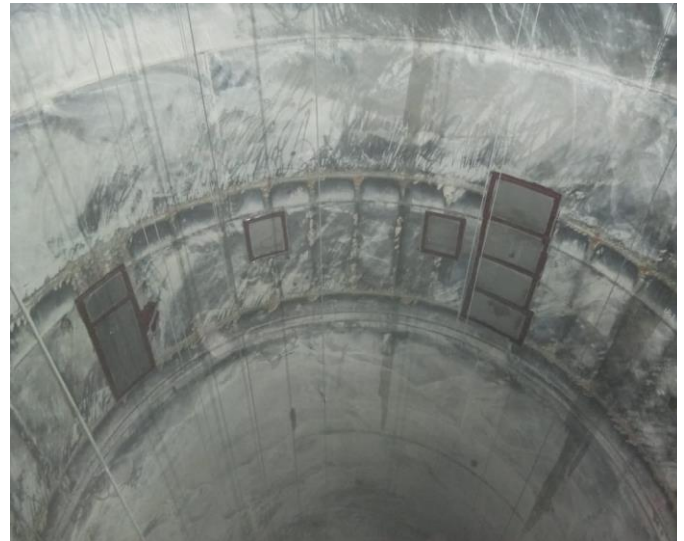
Protecting weld joint areas with Duromar EXP

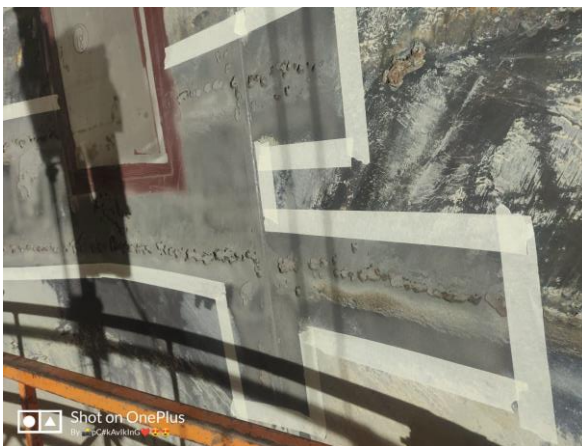
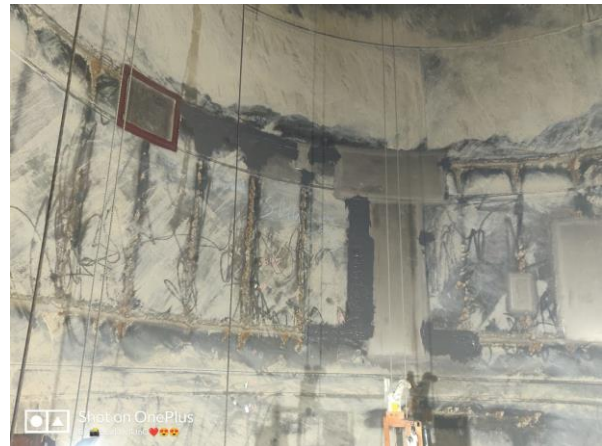
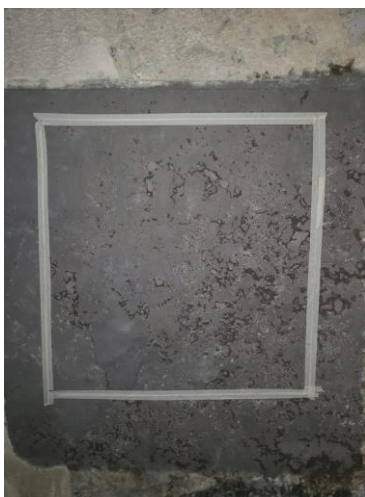
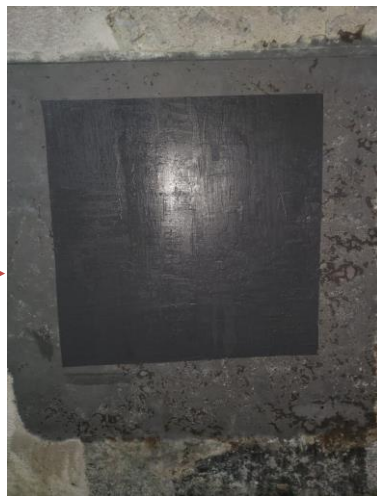
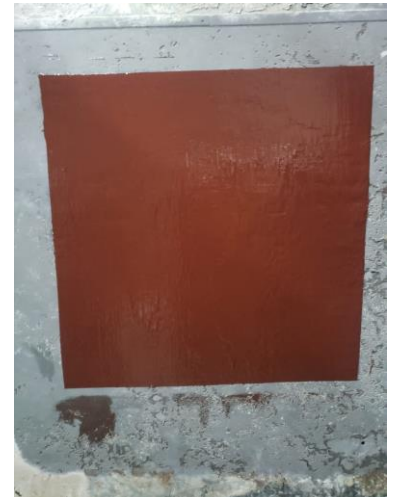
Rebuilding damaged surfaces with Duromar SAR and protecting surfaces with a 2mm thick liner of Duromar EXP

The coating was left to cure for 48 hours, and a spark test was carried out across all coated areas to detect any pinholes and rectify the same accordingly.

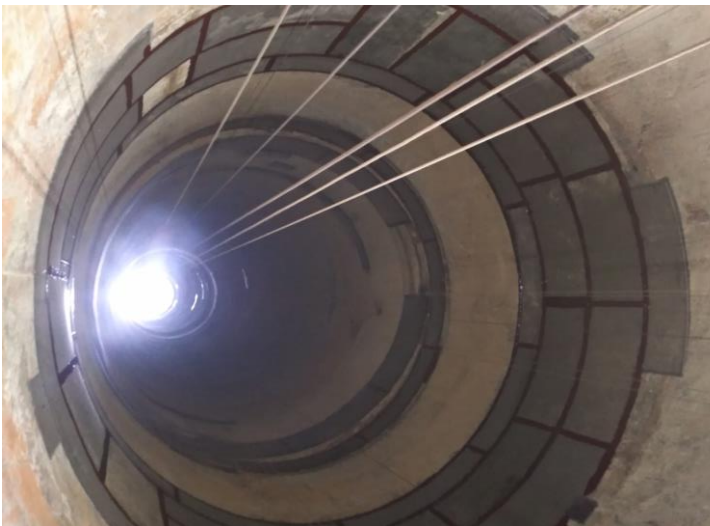
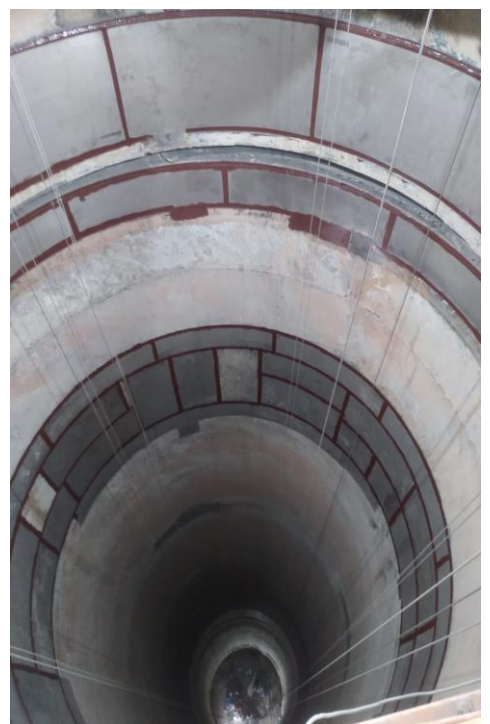
Rebuilding severely corroded portions of chimney stack with Duromar SAR and protecting corrosion sensitive areas with Duromar EXP.

Arudra managed to protect an approximate surface area of 300 m² across varying elevations (upto 225 metres in height) over a span of 12 days. – with engineers working round the clock over 2 shifts each day.
