WET FGD ABSORBER BOX BEAM SURFACE REPAIR

Corrosion & Erosion protection - Duromar® coatings & linings

Protective coating & lining of Wet FGD Absorber Box Beam		
1	Industrial Unit	1300 MW Thermal (Coal Fired) Power Plant
2	FGD System Equipment	Absorber Box Beam - Wet FGD System
3	No of operating years	8
4	Year of Coating Installation	March, 2021
5	Surface Metal Type	Carbon Steel
6	Operating Conditions	Max Wet operating temp: 120°C
		pH level: 3 -12
		Surface Area coverage – 100 m ²
		Inspection Date: March, 2022

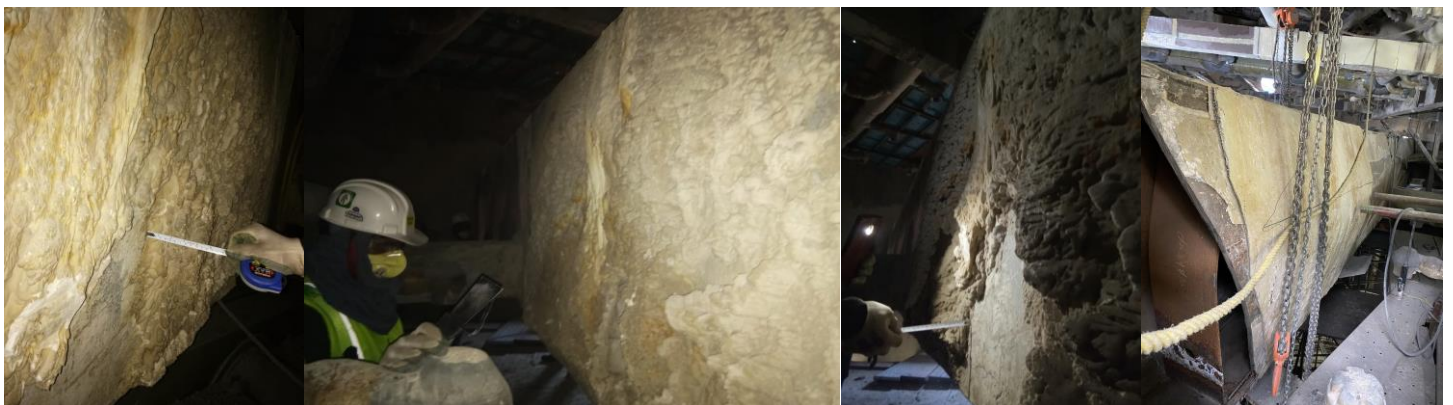
The absorber box beam surfaces of a fully operational 8-year-old Wet FGD system was severely damaged, due to the varying temperature levels & viscosity of the flue gas flowing through the ducts under continuous operation.

The existing FRP linings (3mm and more) had given away in most areas of the box beam and corrosion had aggravated across these beam systems, as a result weakening the overall structural integrity of the wet FGD absorber.

- i. Severely corroded box beam surface and peel-off of existing FRP and Vinyl ester liners.
- ii. Wall thickness loss noted upto 5mm across several portions of the box beam with excessive scaling.
- iii. Extensive erosion and metal damage across various areas of the box beam surface
- iv. Frequent downtime and weld repair of dissimilar metal plates carried out to tackle on going corrosion & erosion issues.

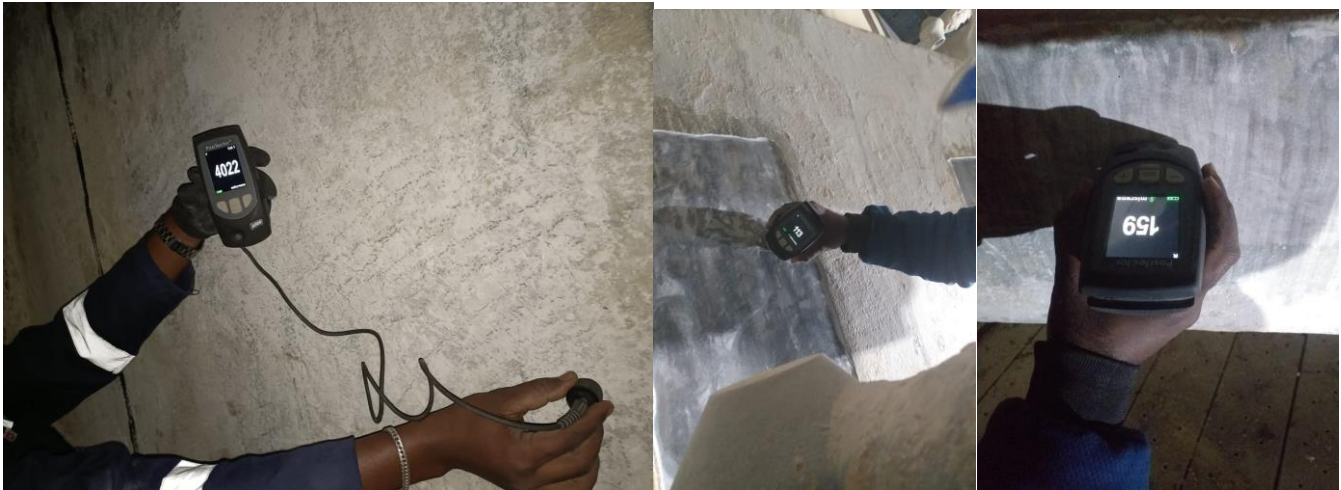
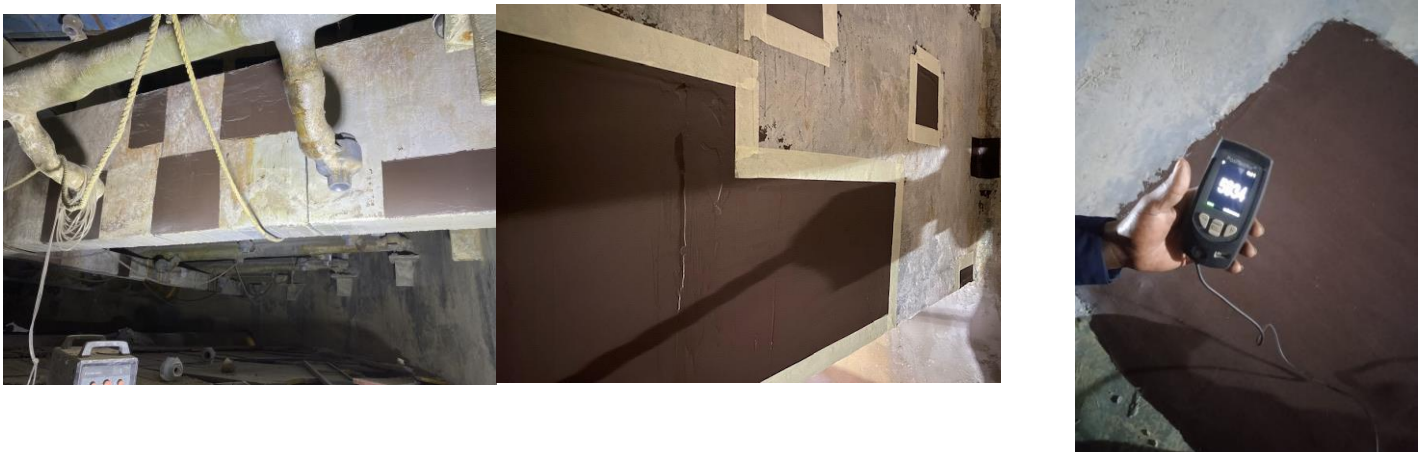
- i. Installation of scaffolding & cleaning entire internal surface of the box beams.
- ii. Holiday mapping & inspection of the surface of the box beams and identifying the areas which required rebuilding.
- iii. Sweep blasting the surfaces as per SSPC 10 standards to achieve a profile of 75 microns in minimum.
- iv. Installing the Duromar® HPL – 2131 100% solid epoxy liner across the marked portions and ensuring a coating thickness of 3mm – 4mm was achieved.
- v. Letting the Duromar® HPL – 2131 cure for 48 hours and conducting a thorough holiday tests across coated areas.

Upon inspection, the amount of corrosion & scaling damage seemed to be significant, thereby requiring Arudra to propose a rebuild solution using a thick, chemical and corrosion resistant epoxy liner Duromar® HPL 2131.

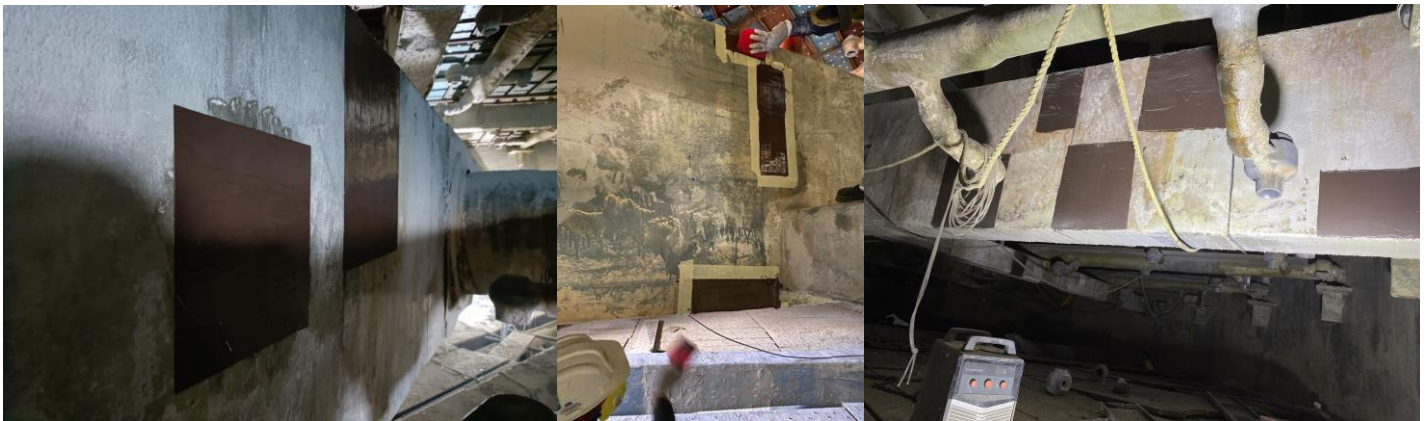
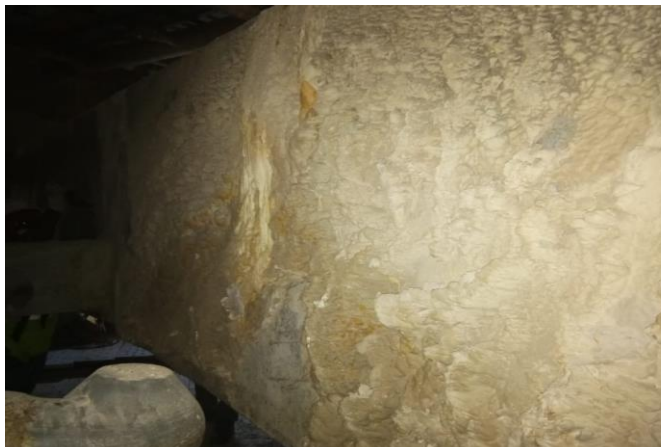
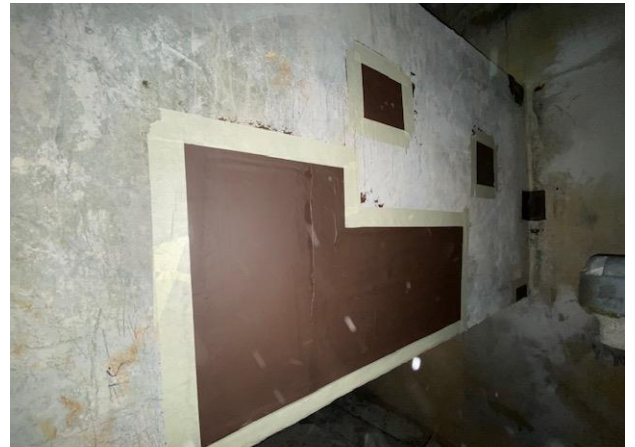
The condition of the coatings installed on the absorber box beam were installed for the first time after 12 months of operation and inferred:

- i. No wear out of installed coating materials.
- ii. Complete compatibility and adhesion with existing carbon steel & FRP surfaces.
- iii. Outstanding corrosion, chemical and temperature resistance under continuous operation.
- iv. Zero wall thickness reduction on Box Beam surfaces.
