Repair & Rebuild of Acid Neutralisation Trench Lines using Duromar® DF-1301, DuroFil, and Duromar® DF-4301

Case Study

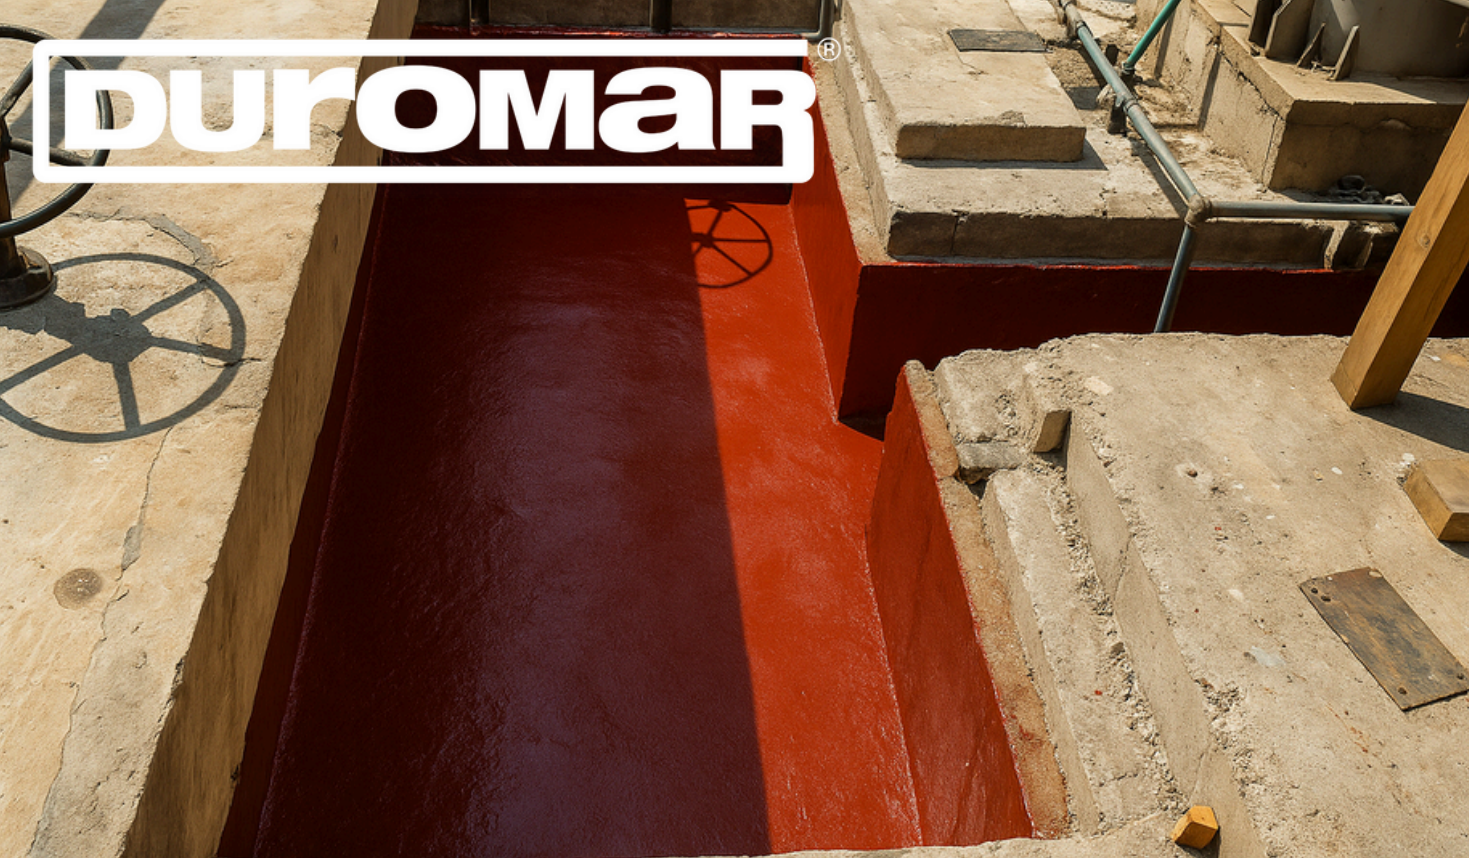
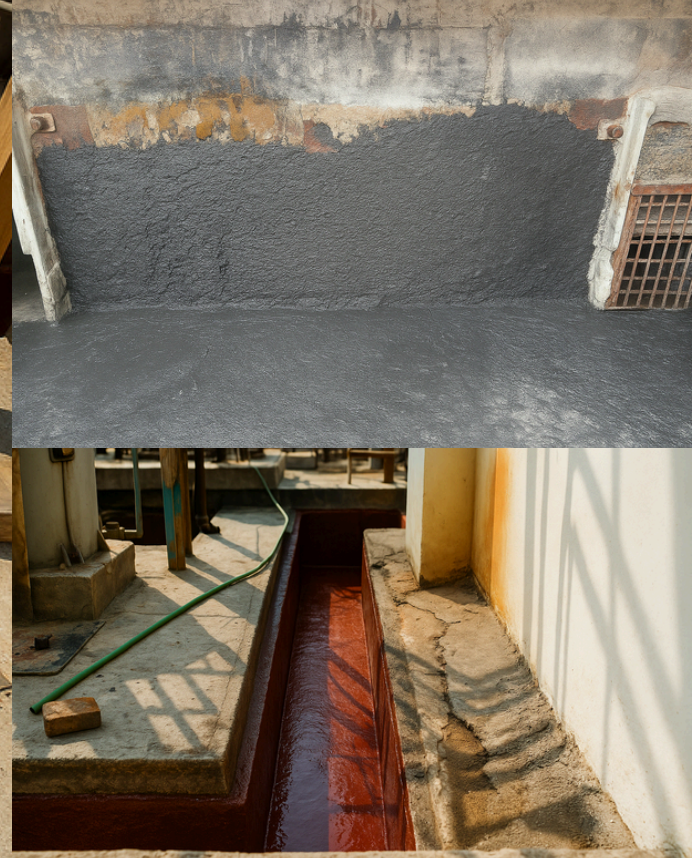
A chemical process plant reported severe deterioration of their acid neutralisation trench lines caused by continuous exposure to aggressive chemicals and mechanical wear. The damaged concrete surfaces exhibited deep cracks, erosion, and chemical attack, posing a risk of leakage, structural weakening, and non-compliance with safety standards.

Arudra Coatings proposed a composite repair and rebuild system using Duromar® high-performance polymer linings and rebuild materials. The approach involved:

- Surface restoration with a high-strength filler to rebuild the eroded trench profile.
- Application of a chemical-resistant barrier lining to ensure protection against strong acids, alkalis, and corrosive effluents.
- Seamless monolithic protection for long-term durability and reduced maintenance.

- Surface Preparation:**
- Mechanically cleaned and abrasive blasted the trench surface to remove laitance, chemical residues, and loose concrete.
 - Ensured a sound, roughened profile for proper adhesion.
- Sealing the Concrete with Duromar DF-1301**
- A thin coat of DF-1301 was applied to act as a primer, enhancing adhesion between substrate and topcoat.
- Rebuilding with DuroFil**
- Applied DuroFil to restore the damaged and eroded sections of the trench walls and base.
 - Smoothed and leveled to achieve original trench geometry.
- Final Protection with Duromar® DF-4301**
- Applied multiple coats of DF-4301 to achieve the specified dry film thickness.
 - Created a seamless, high-density lining capable of withstanding continuous exposure to corrosive effluents.
